# John McGibbon Real Estate Inspections, Inc.

## REAL ESTATE INSPECTION REPORT

246 Residential Street, Your Town, CA 90000

06/27/2005

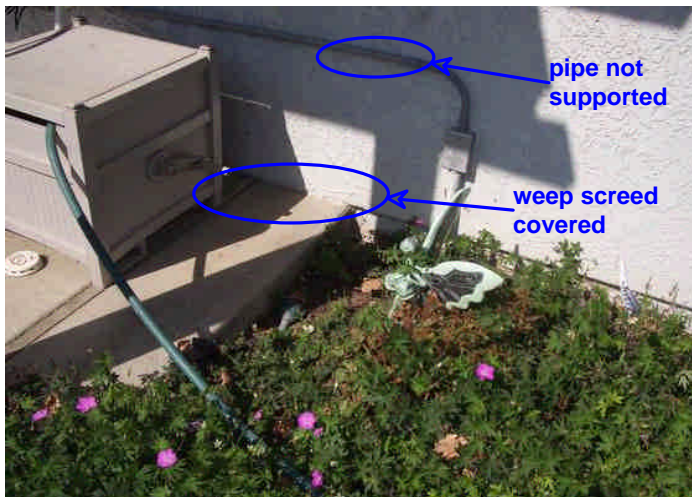
1.3 - Some of the weep-screed at the base of the stucco has been covered with or is too close to earth or masonry especially at the right side. The weep-screed is designed to allow any moisture that penetrates the stucco to drain. Consult the termite inspector for information regarding the consequences of inadequate weep-screed clearance. The area below the weep-screed must be kept clear.

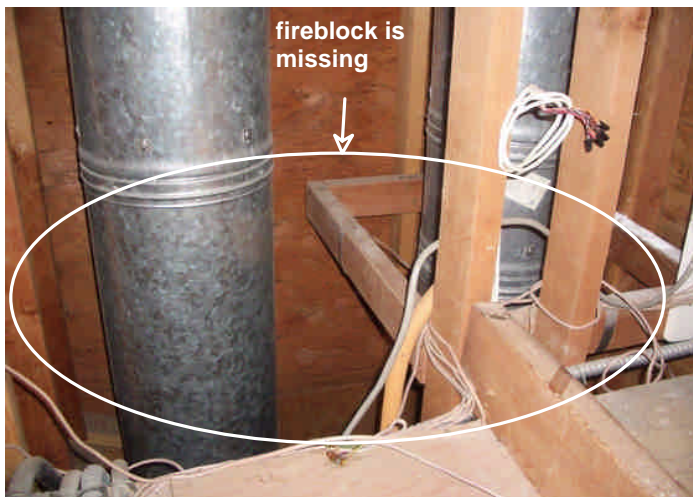
4.3 - Fire block, or the metal flashing that is required to surround pre-fabricated chimney flues on the floor of an attic, is missing or incomplete. This component is designed to isolate flames from the oxygen-rich atmosphere of an attic, and thereby inhibit the spread of flames. We recommend installation of this safety fireblock.

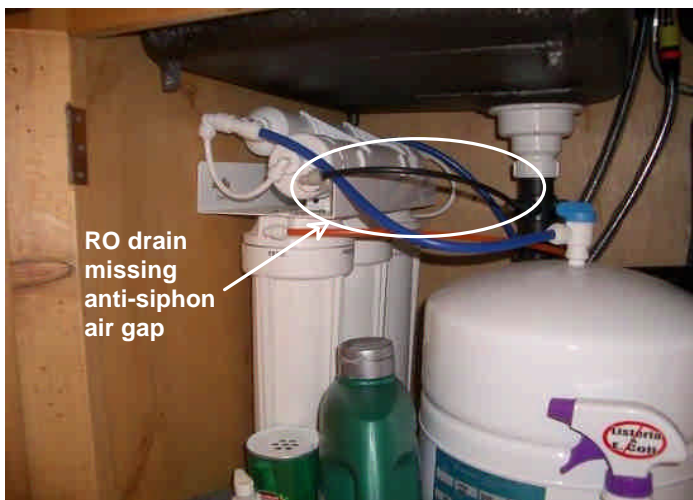
5.2 - The Reverse Osmosis drinking water system under the kitchen sink is connected to the drain without the benefit of an Air Gap device. Although we do not inspect RO systems, we do look for cross connections of the potable water and waste water plumbing components. This is a health hazard and should be corrected. Refer to plumber.

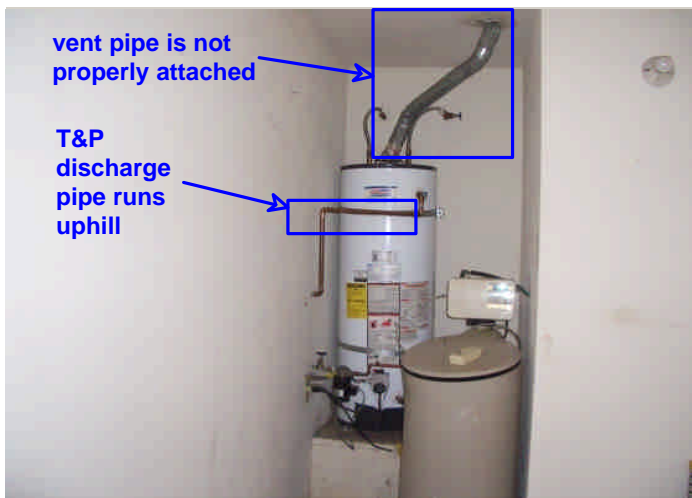
5.7 - The discharge pipe from the pressure relief valve has been incorrectly plumbed uphill. To prevent possible hard water deposit blockages and assure proper function, the discharge pipe should slope to drain.

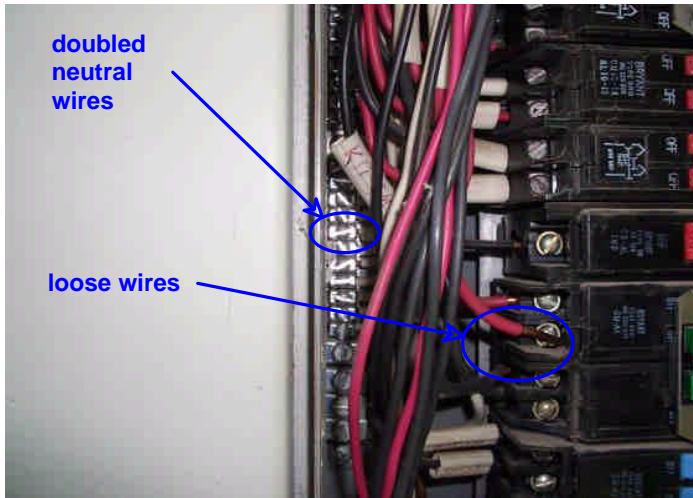
6.4 - There are loose wires that appear to have once been connected to a breaker labeled Jacuzzi. Contact a qualified electrician for evaluation and repair.

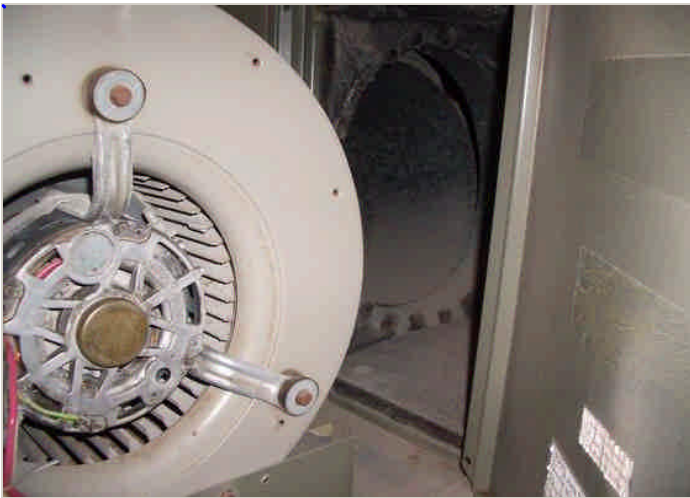
7.4 - The return-air compartment is dirty, and dirt has passed beyond to contaminate the system. Contact a qualified HVAC contractor for evaluation.

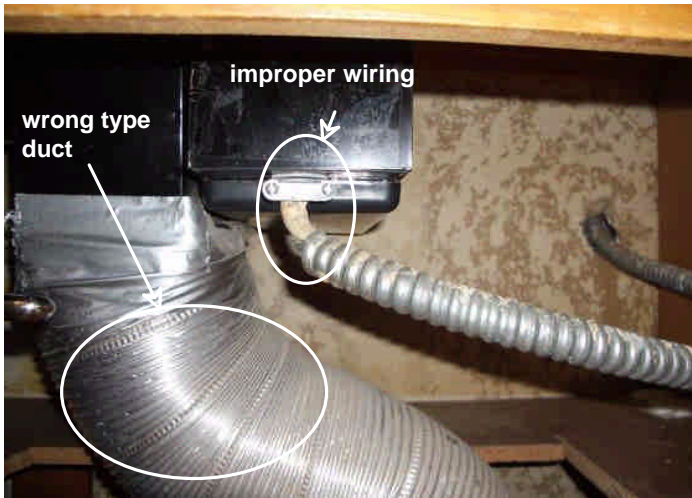
10.1 - The electrical connection to the cook top has been incorrectly made. Contact a qualified electrician for evaluation.

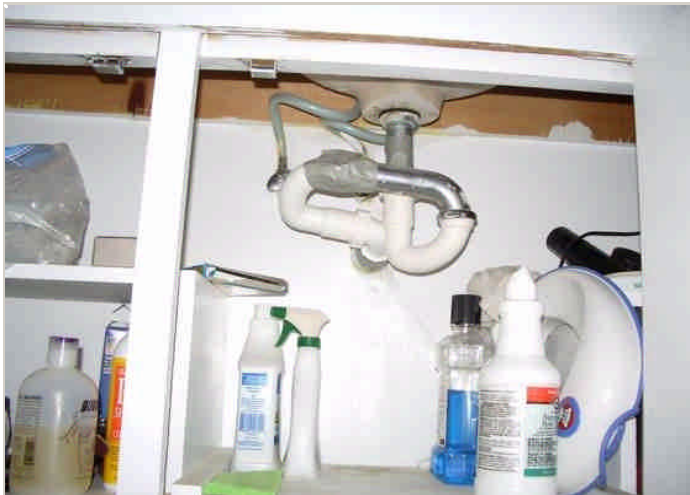
14.2 - Various plumbing fittings have been put together to create what amounts to an 'S' trap configuration. Such traps are not approved because their water seals can be easily siphoned away, which would allow sewer gases to contaminate the residence. This is an unconventional installation that even employs duct tape. Contact a qualified plumber for evaluation.

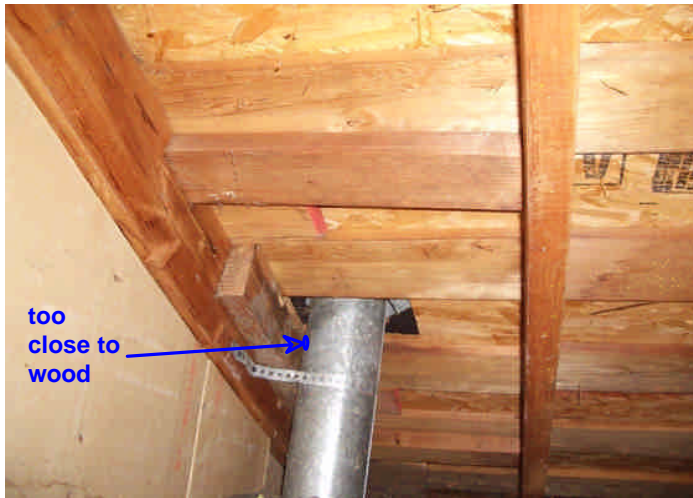
16.4 - The heating vent pipe is too close to combustible material, and should be serviced. This type of vent pipe is required to be at least one inch away from any combustible material.
